# PROPERTY INSPECTION REPORT

**Inspection Address:** 1234 rue Example, Laval

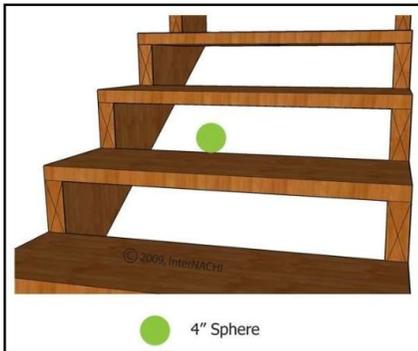
More than 4" spacing is a safety hazard

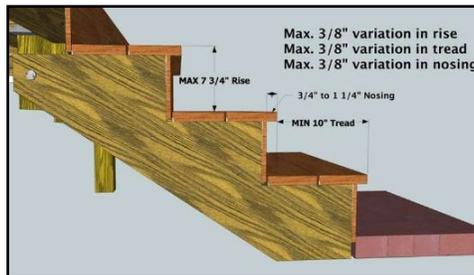
Proper measurements for stairs

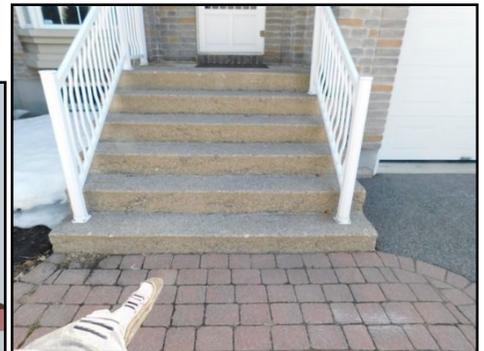
Uneven steps were observed, these are a trip hazard.

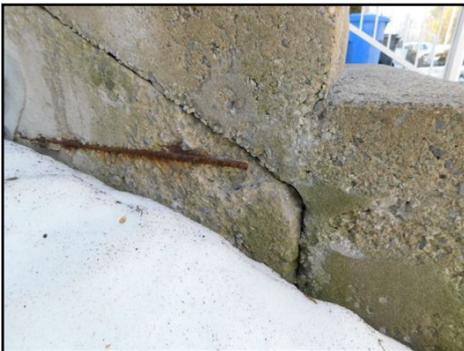
Due to the deterioration of the concrete on the side, there is one rebar that is exposed. Exposed and rusted rebar's can weaken the concrete around the area. Repair as needed. Contact a certified cement finisher.

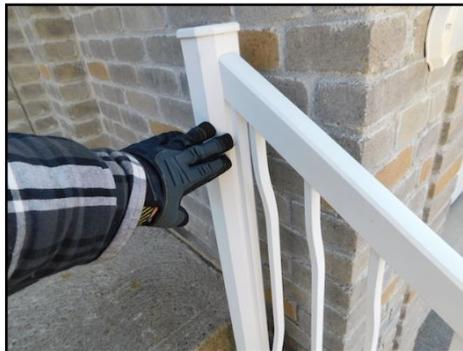
Loose handrail noted on the main stairs. This is considered a safety hazard and it should be corrected to enhance safety.

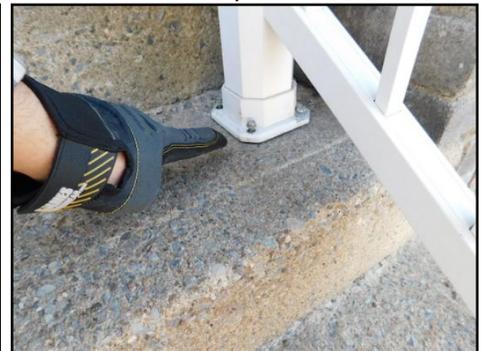
Loose handrail noted on the main stairs. This is considered a safety hazard and it should be corrected to enhance safety.

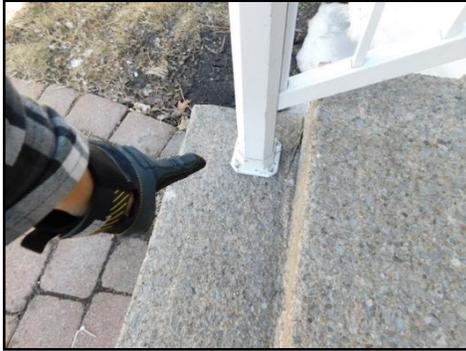
Loose handrail noted on the main stairs. This is considered a safety hazard and it should be corrected to enhance safety.

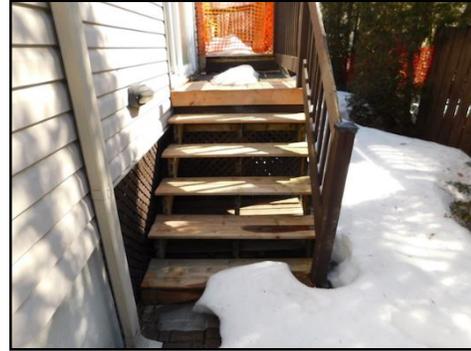
Uneven steps were observed, these are a trip hazard.

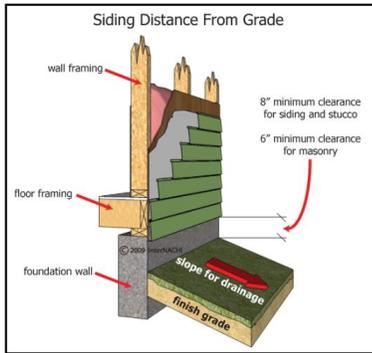
Proper distance required for siding

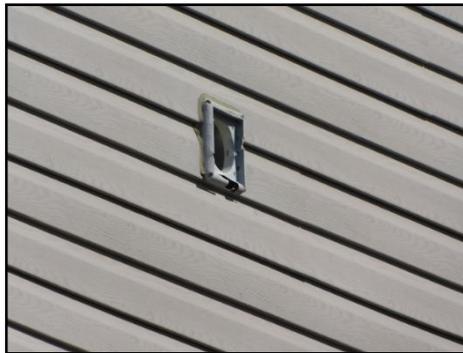
All cracks and openings on exterior coverings should be sealed and repaired to prevent water infiltration and further damages. (Including the openings for the bathroom vents. Risk of wildlife entering). A grill/cover is required

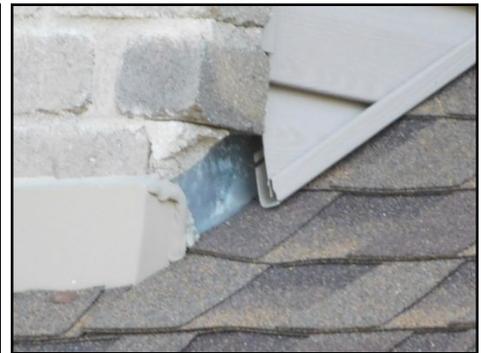
It appears that there may be a small brick or flashing missing just above the garage roof area. This is a risk of water infiltration. Repair is required to prevent possible water intrusion.

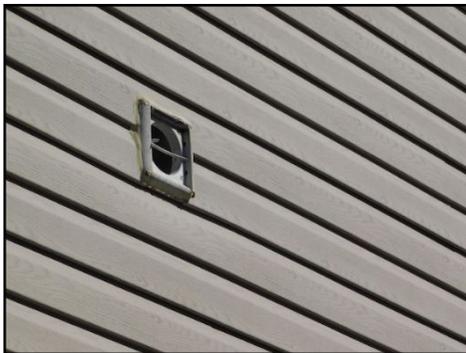
All cracks and openings on exterior coverings should be sealed and repaired to prevent water infiltration and further damages. (Including the openings for the bathroom vents. Risk of wildlife entering). A grill/cover is required

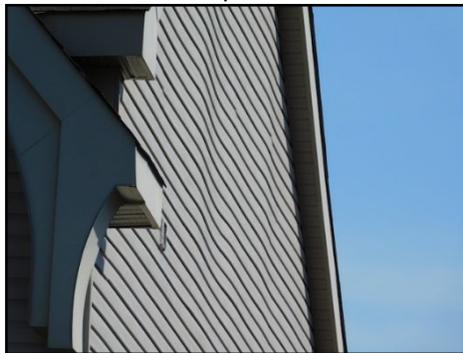
Minor warping observed, this is sometimes due to tight installation and previous house settlement

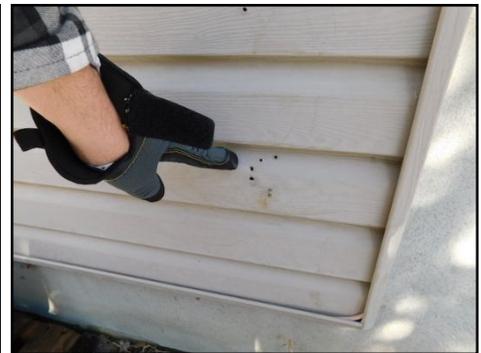
All cracks and openings on exterior coverings should be sealed and repaired to prevent water infiltration and further damages. (Including the openings for the bathroom vents. Risk of wildlife entering). A grill/cover is required

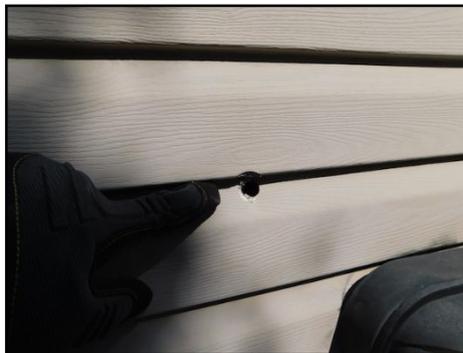
All cracks and openings on exterior coverings should be sealed and repaired to prevent water infiltration and further damages. (Including the openings for the bathroom vents. Risk of wildlife entering). A grill/cover is required

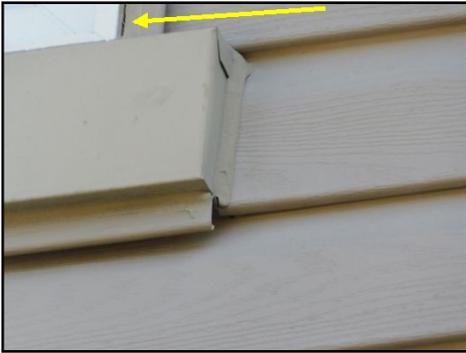
Minor caulking needed around the house, touch up the areas which may be vulnerable to water infiltration.

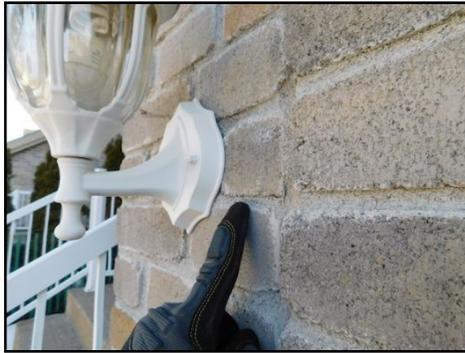
Note: It is recommended to caulk around all fixtures and exterior penetrations. Leaving areas of penetration with missing, improper or defective caulk could result in leakage, rot and/or even the possibility of mould formation. Regular caulk of all potential leakage areas should improve these conditions.

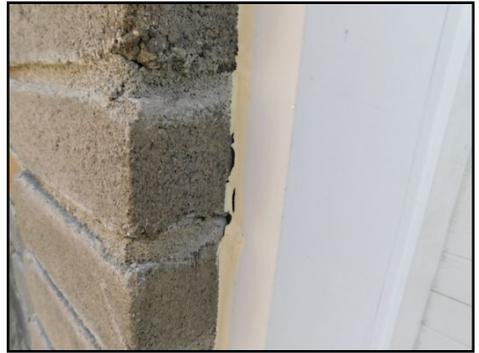
Examples of caulk needed around the house

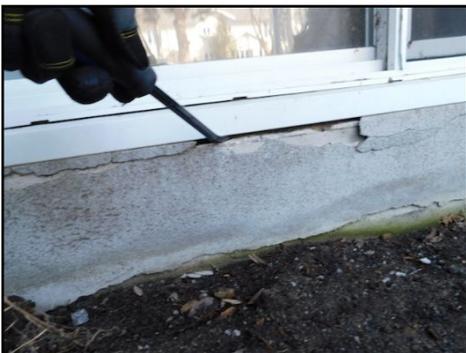
Minor caulking needed around the house, touch up the areas which may be vulnerable to water infiltration.

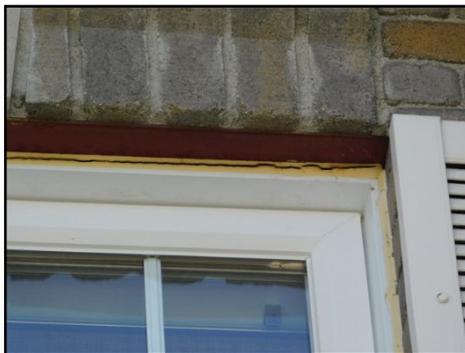
Examples of caulk needed around the house

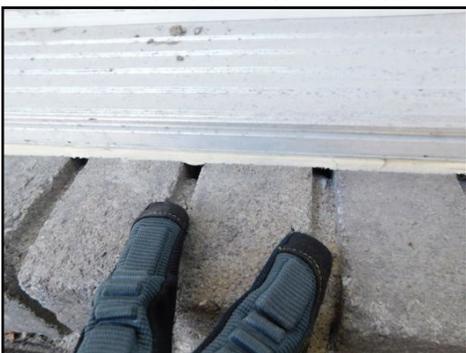
Minor caulking needed around the house, touch up the areas which may be vulnerable to water infiltrations.

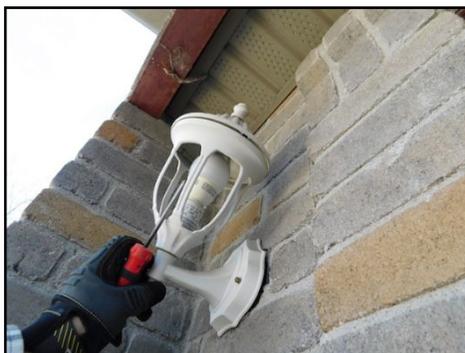
Note: It is recommended to caulk around all fixtures and exterior penetrations. Leaving areas of penetration with missing, improper or defective caulk could result in leakage, rot and/or even the possibility of mould formation. Regular caulk of all potential leakage areas should improve these conditions.

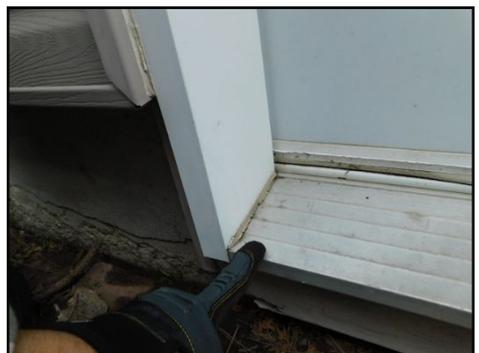
Examples of caulk needed around the house

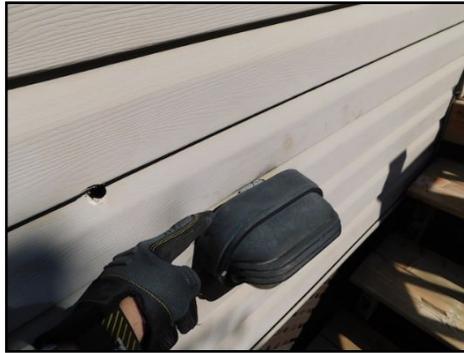
Examples of caulk needed around the house

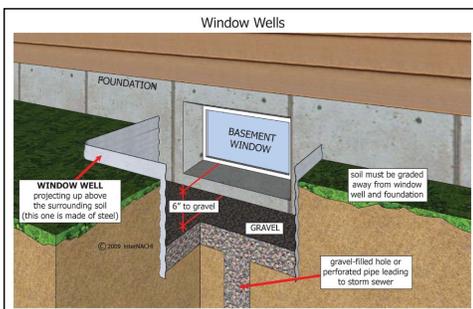
Proper window well installation

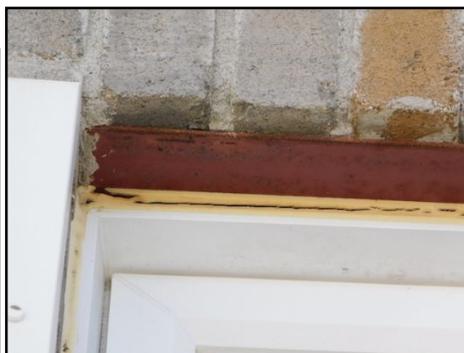
Lintels above the windows (and door) are not painted. Application of exterior paint for extra protection to prevent rusting is recommended.

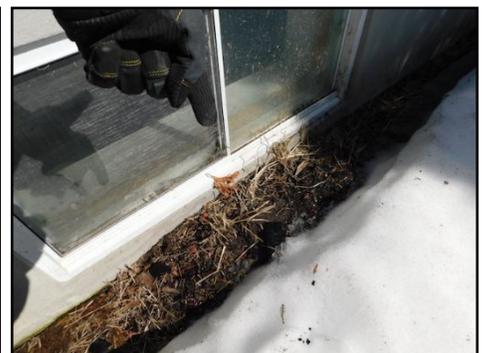
Missing window wells noted on the basement windows. Installation recommended. (Window wells are required on all windows placed within 6 inches to the ground level to prevent snow accumulation and water infiltration).

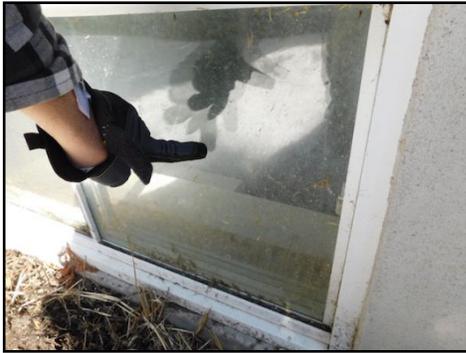
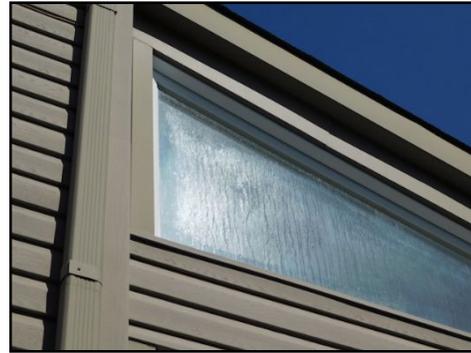
The basement windows appear to be the original windows with single pane windows. These are prone to higher heat loss and condensation. Although they appear serviceable at the time of the inspection, replacement and upgrading is recommended. (No signs of major water damage was noted at the time of the inspection).

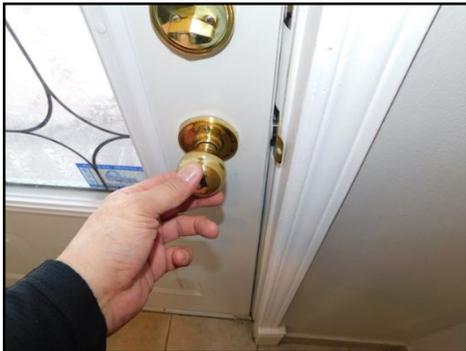
Slightly loose doorknob, minor adjustment needed

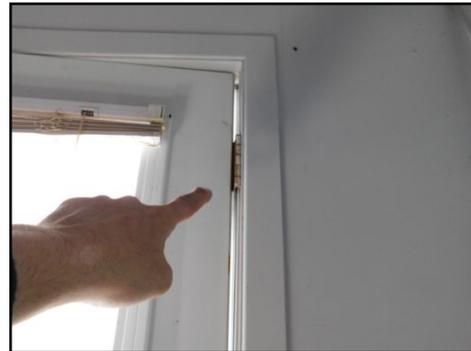
Side door hinge is loose and needs to be adjusted. (As seen from inside the garage)

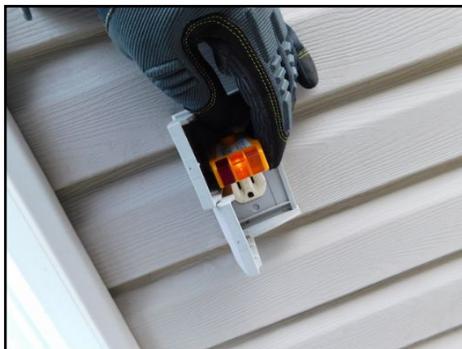
Exterior outlets are not protected with GFCI. Installation recommended for today's standards.

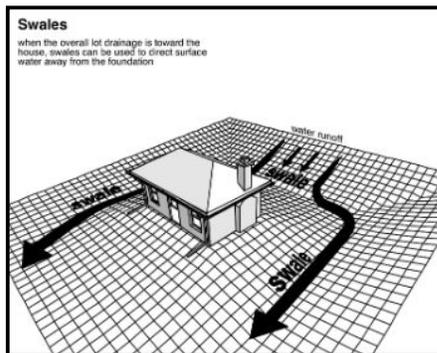
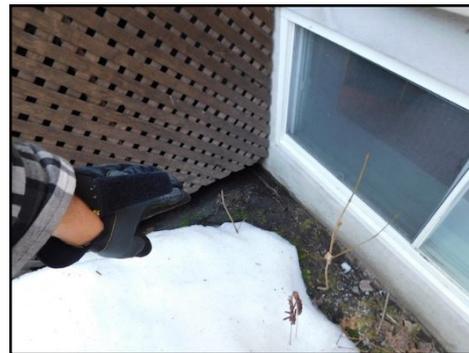
Negative slope in areas

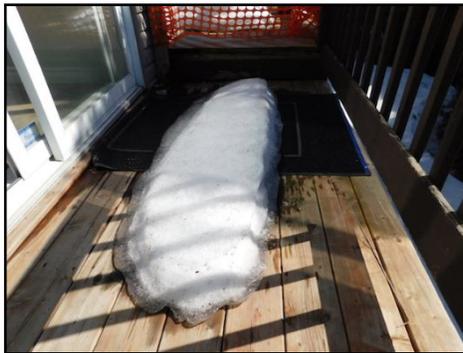
The deck is not painted and should be painted with exterior waterproof paint for wood. This will prolong the life of the deck.

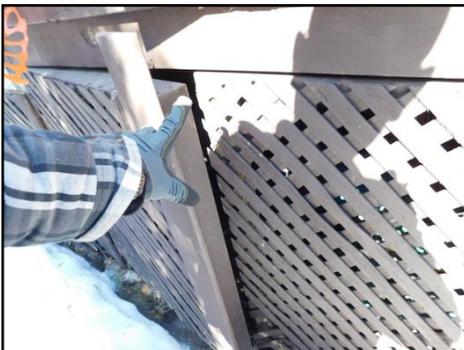
Not verifiable underneath due to snow/ice

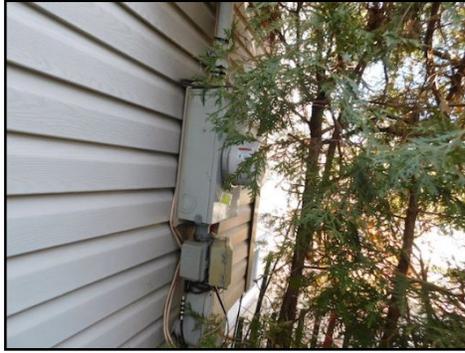
It is strongly recommended to cut all branches that are/may physically touch the building to prevent damages.

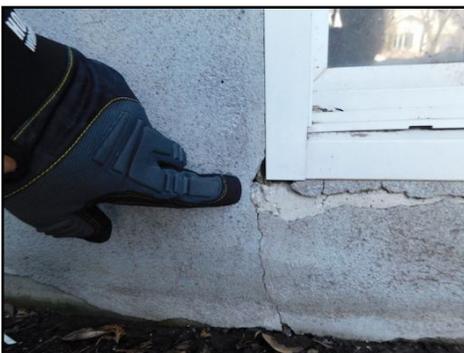
(With cracks) Presence of minor/important cracks were observed in areas around the foundation. They require further verification by a certified foundation specialist, and to be repaired, if needed

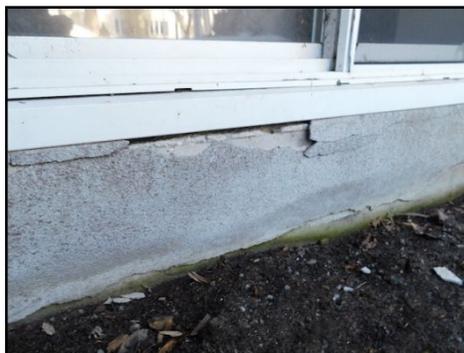
Cement parge coat is flaking/deteriorated in some areas. Recommend review for repair as necessary.

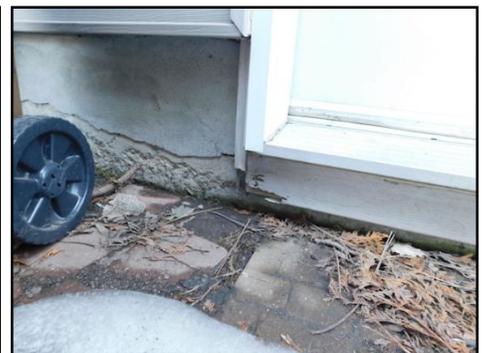
Cement parge coat is flaking/deteriorated in some areas. Recommend review for repair as necessary.

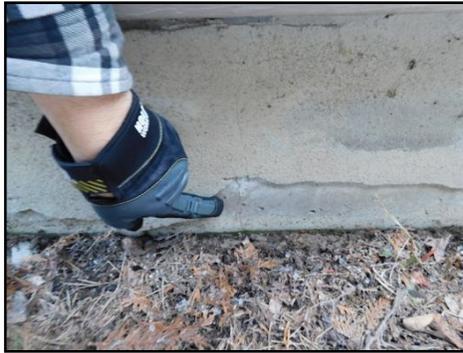
Minor foundation crack

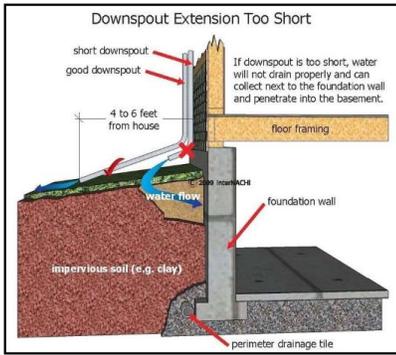
Proper drainage and downspout extensions. Quebec is receiving more water now than previously, it makes sense to increase the capacity of the gutters and grow the size of the downspouts to maximize the drainage capacity. Keep water away from the foundation as a rule.

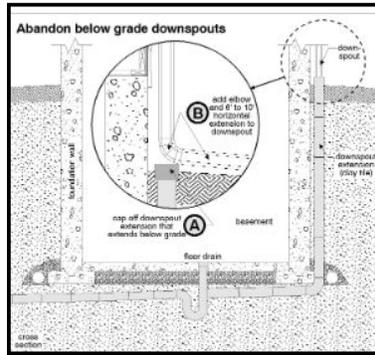
Below grade should no longer be used

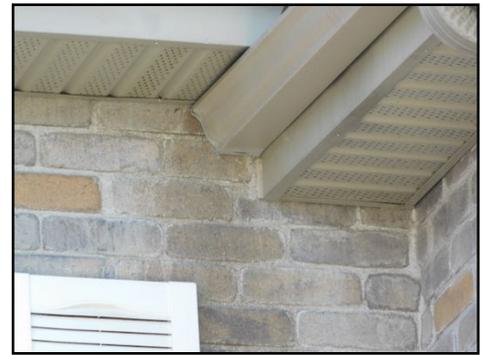
Evidence of water sliding on the side of the wall and discoloration on the bricks was noted. This condition can lower the life expectancy of the bricks and the mortar. Corrections are recommended to allow proper drainage to prevent further damages.

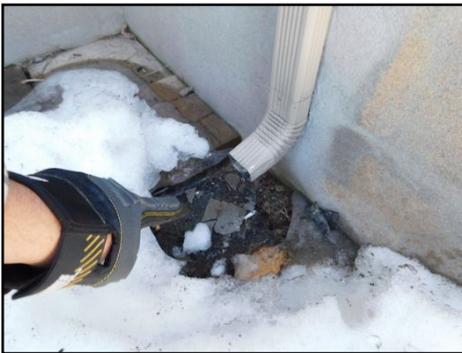
Missing proper extensions and gutters downspout discharges water by the foundation. Recommend installation of extension to ensure proper drainage away from foundation to prevent seepage.

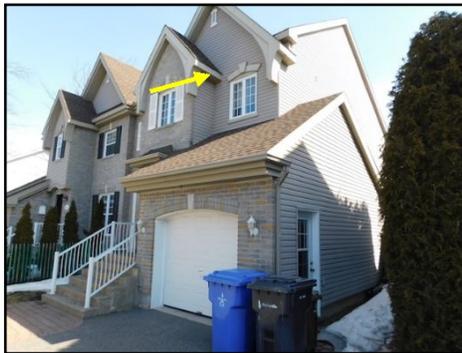
Missing gutters on the upper portion of the roof, draining onto the lower roof. This condition may lead to premature failure of the lower portion.

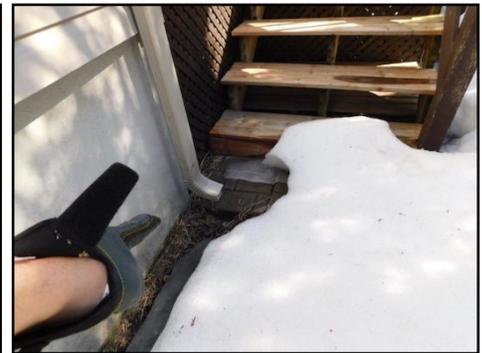
Missing proper extensions and gutters downspout discharges water by the foundation. Recommend installation of extension to ensure proper drainage away from foundation to prevent seepage.

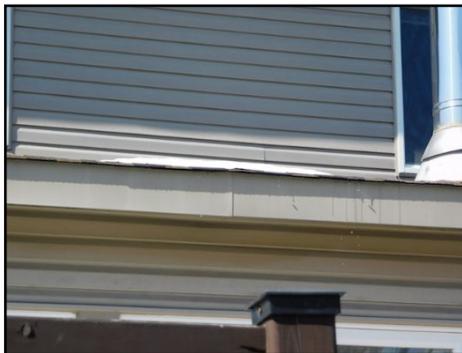
Missing gutter on the rear /solarium roof. Recommend installing gutter with downspout.

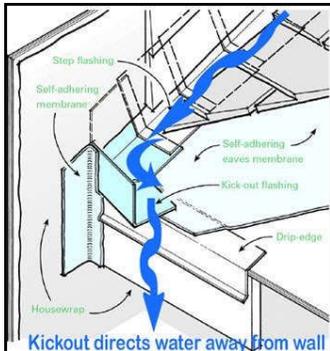
Kickout directs away from wall

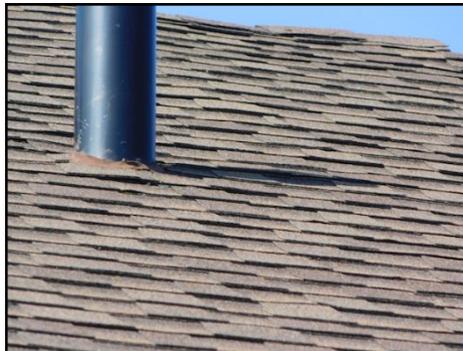
(Flashing installed under shingles) The flashing of the roof penetrations are installed under the shingles. (The lower portion of the flashing should be installed over the shingles. This will allow the water slide on the surface). Application of proper caulking and close monitoring for any signs of leaks is recommended. (Part of regular maintenance when flashing installed under shingles)

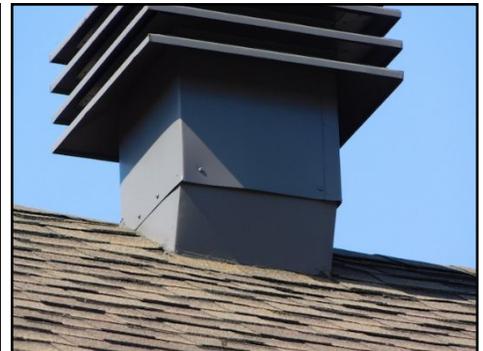
(Flashing installed under shingles) The flashing of the roof penetrations are installed under the shingles. (The lower portion of the flashing should be installed over the shingles. This will allow the water slide on the surface). Application of proper caulking and close monitoring for any signs of leaks is recommended. (Part of regular maintenance when flashing installed under shingles)

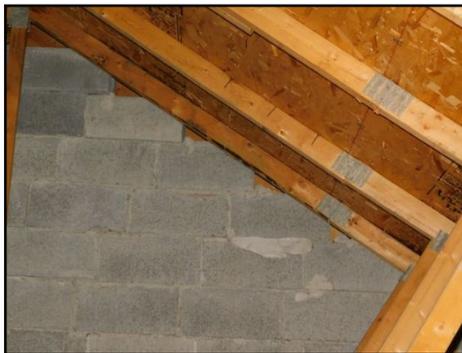
Incomplete fire wall was noted (Triangle openings by the ends where it meets the roofing structure). This can be filled up with fibreglass insulation or even steel wool stuffed into the openings. (It is recommended to consult your insurance company regarding this situation along with a qualified contractor for further evaluation of all proper repairs and corrections along with all associated costs).

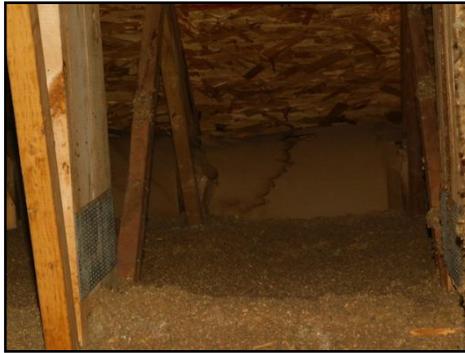
Garage attic: Evidence of previous leaks observed, however it appears dry and no other signs of active water infiltration was observed at the time of the inspection

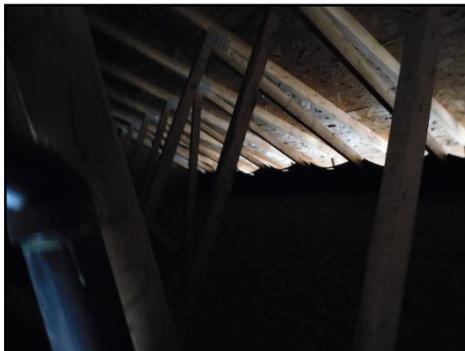
Soffits are open which allows proper ventilation. (The ideal situation for proper attic ventilation is when the air enters the attic from the lowest point (Soffit) and exits from the highest point (Roof vent). This circle of ventilation could be interrupted by blocked soffits, roof vents being too close to each other and even gable vents. And having an inadequate attic ventilation could result premature failure of roofing member, humidity build up, rot and even creation of mold).

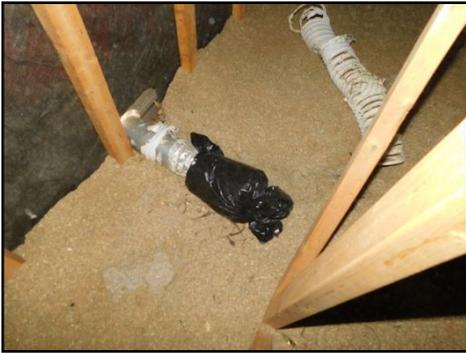
The original duct exiting the attic has been cut off and closed off with a garbage bag. This was due to the fact that birds had entered and also made a nest. One decomposing bird was observed near the area. Recommend removing all contaminated and dirty insulation and debris and replace the bathroom vent to vent properly to the exterior

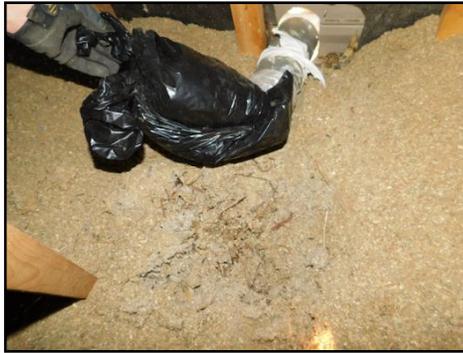
The original duct exiting the attic has been cut off and closed off with a garbage bag. This was due to the fact that birds had entered and also made a nest. One decomposing bird was observed near the area. Recommend removing all contaminated and dirty insulation and debris and replace the bathroom vent to vent properly to the exterior

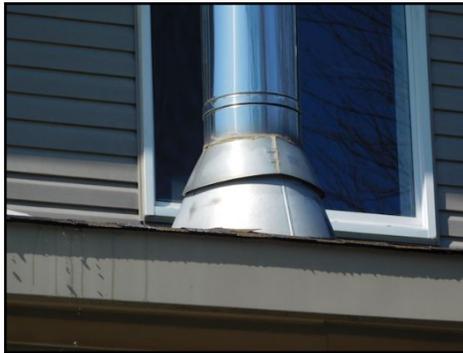
Missing caulking on the edge of the chimney. This condition may lead to water infiltration. Application is required.

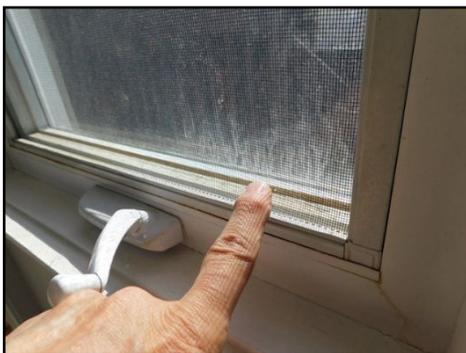
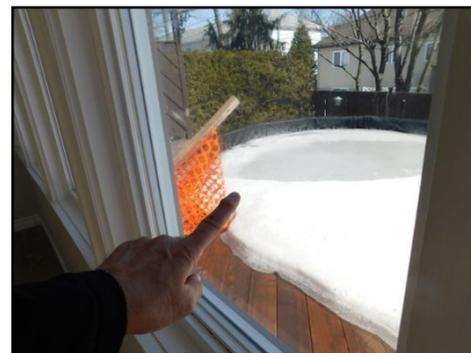
Evidence of fog and/or condensation observed (in solarium) between multiple windows. This condition is often caused lost seal and thermo. The thermopane windows are at the end of their life expectancy. Repairs or replacement is recommended by a qualified contractor.

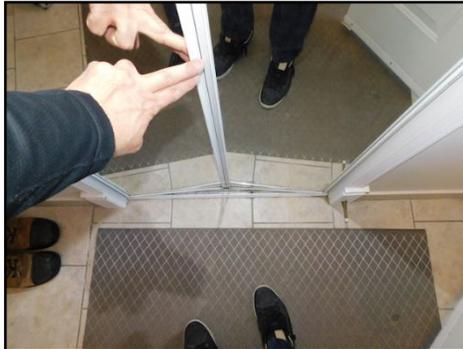
Folding mirrored interior door needs adjustment. Regular adjustment and maintenance is recommended as necessary.

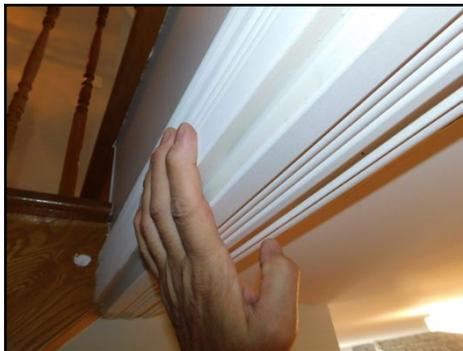
Inadequate head clearance was noted on the main floor stairs. (Safety hazard).

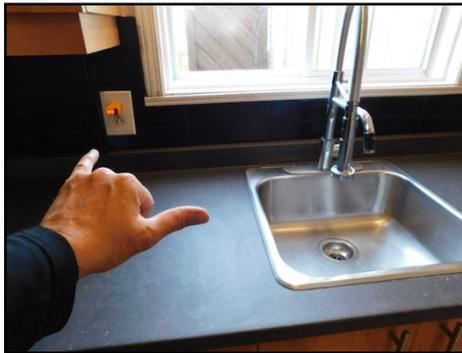
No GFCI protection present, suggest installing GFCI protected receptacles for safety.

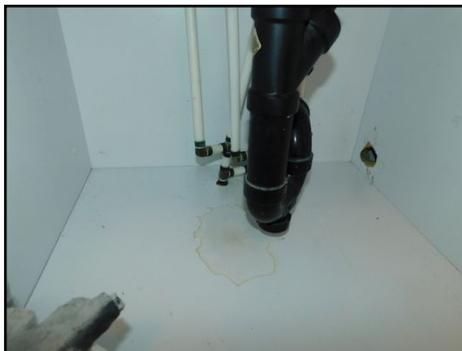
Previous leak observed, no major water damage

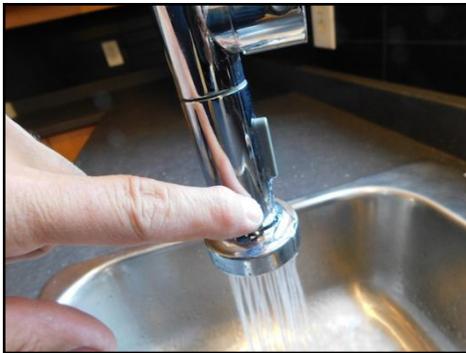
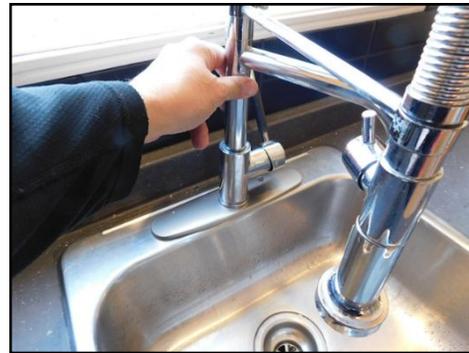
The faucet is loose and it requires to be tighten and adjusted. (This condition may lead to water infiltration and damage over time).

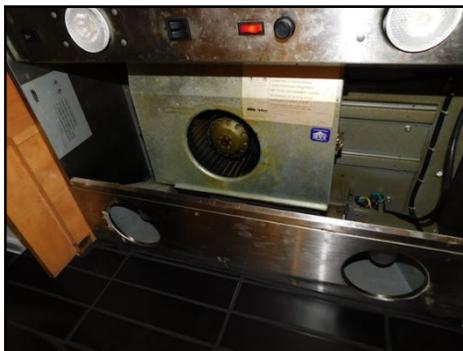
Missing grill. To be installed to enhance safety.

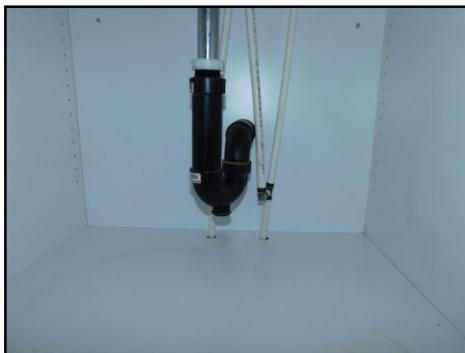
Missing shut off valves, recommend installing them.

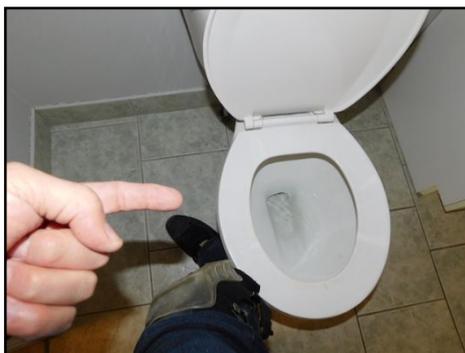
Loose toilet was noted. This condition could result leakage and damages to the subfloor and other components. Corrections are required.

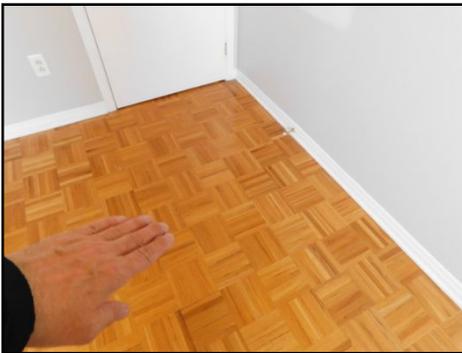
Minor sloping/central compression observed

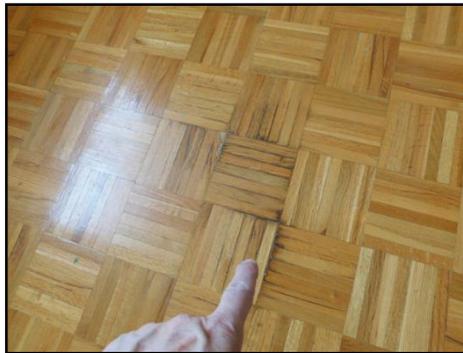
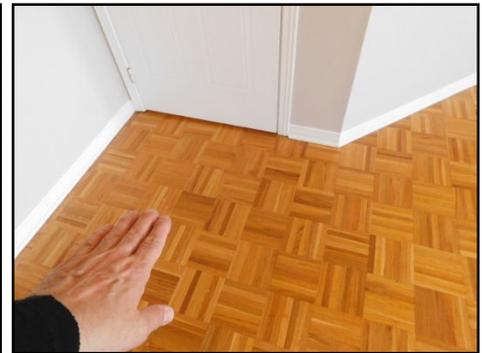
Minor sloping/central compression observed

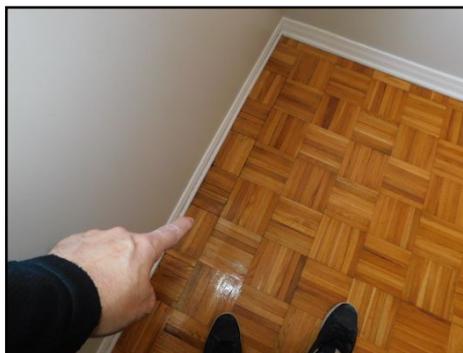
Previous water damage observed in areas. No moisture detected

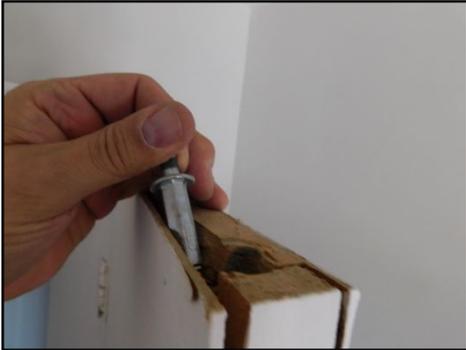
Physical damages noted. Repair / replacement recommended as needed.

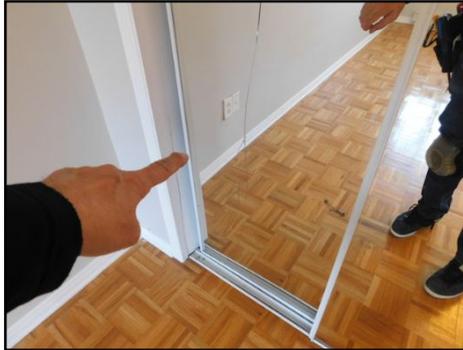
Cracked sliding mirrored door. Safety hazard. Replacement required.

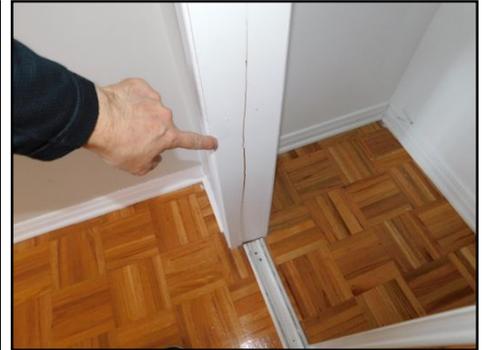
Physical damages noted. Repair / replacement recommended as needed.

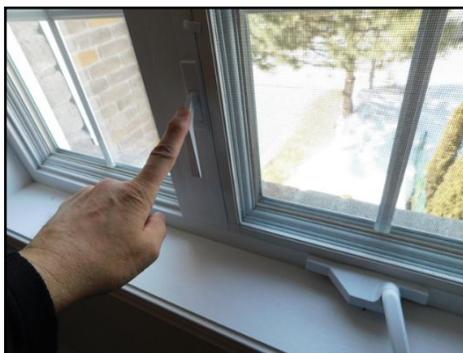
Minor adjustment needed with latches in master bedroom

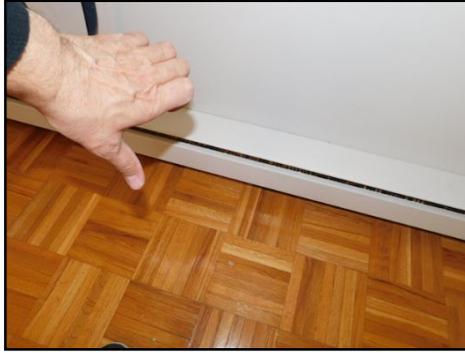
Baseboard heater in master bedroom is not functional. Replacement needed. Contact a certified electrician for estimate and repairs

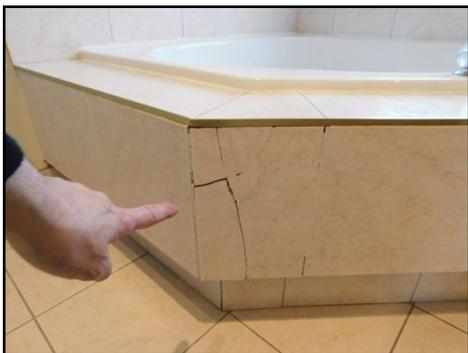
Broken tile(s) observed. This is also a safety hazard, as the edges are sharp. Also risk of water infiltration.

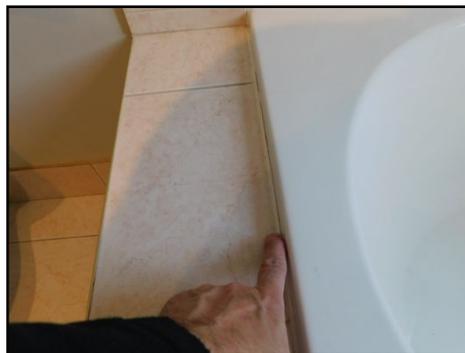
Application of silicone is recommended on all corners to prevent water infiltration and damages. (Part of regular maintenance)

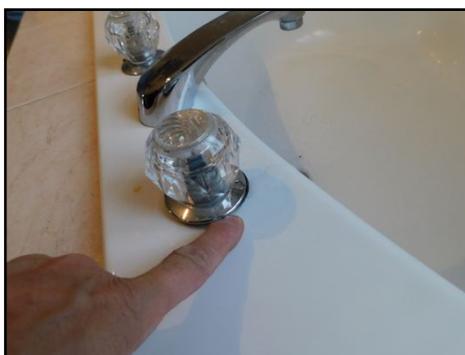
Faucet drips, this condition may lead to water damage in concealed areas. Corrections required.

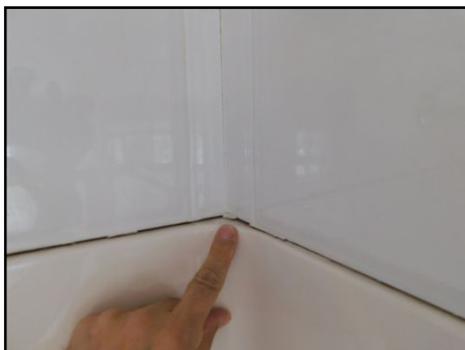
Application of silicone on all corners (including the top area) is recommended and it is part of regular maintenance to prevent water infiltration.

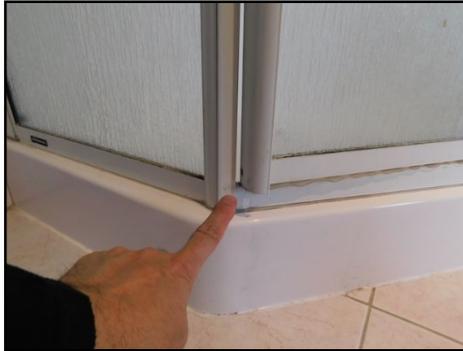
Does not close properly. Rubs at the bottom. Adjustment needed.

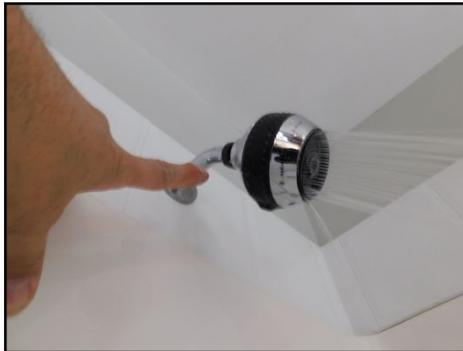
Faucet drips. Minor repair needed.

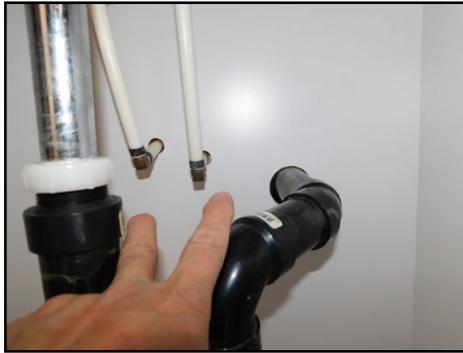
Missing shut off valves, recommend installing them.

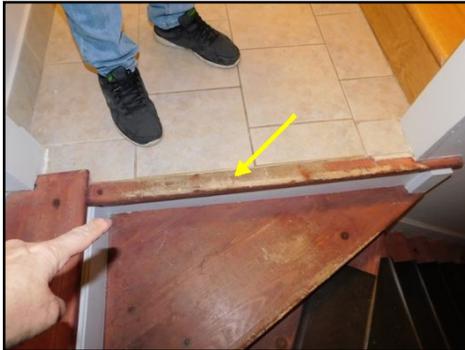
Top step is slightly and is a safety hazard. Repair needed to enhance safety

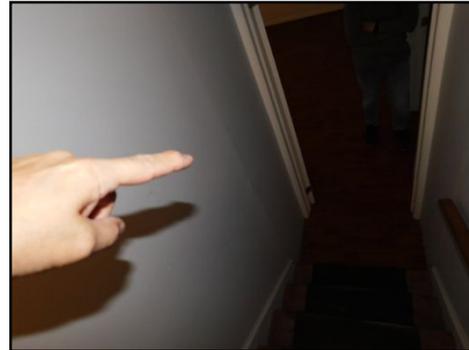
Missing three way switch for proper lighting. Corrections recommended to enhance safety.

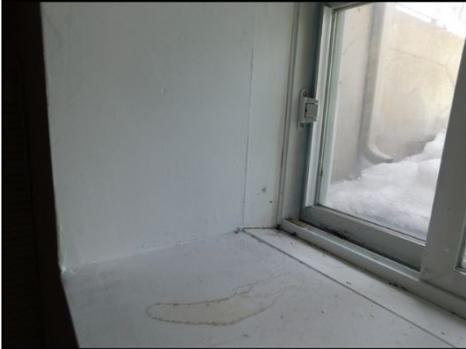
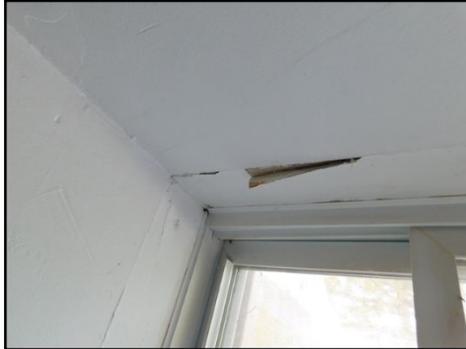
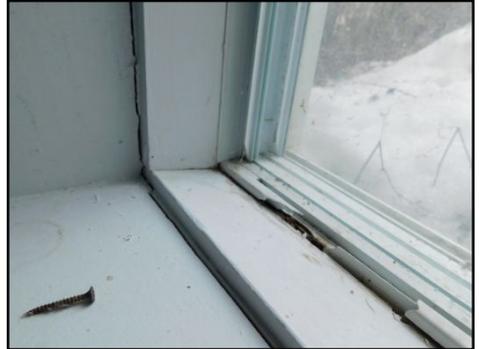
Previous water stains and water damage observed on the windowsill and above the window. No moisture detected. Close monitoring is recommended for any possible further infiltration. This may also be due to lack of caulking on the exterior.

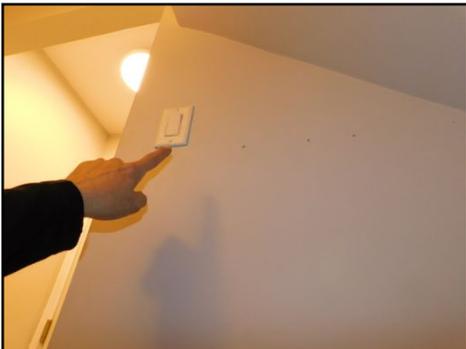
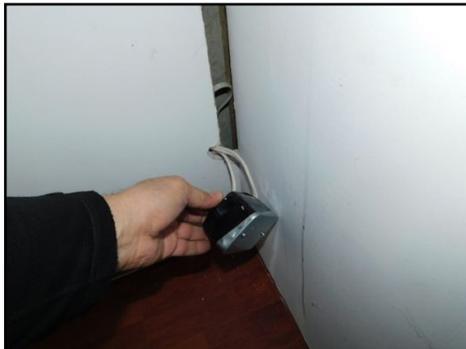
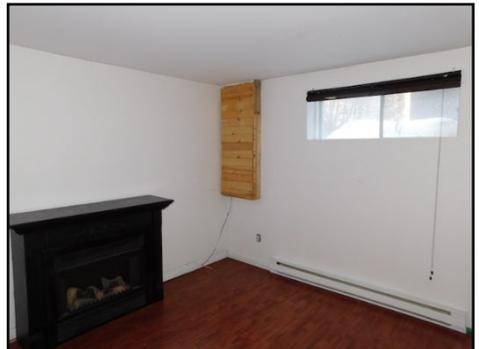
No light switches for the basement. Only light switch for the basement is powered by one light switch installed on the top of the stairs. This is poor workmanship and proper lighting/switches are required in the basement.

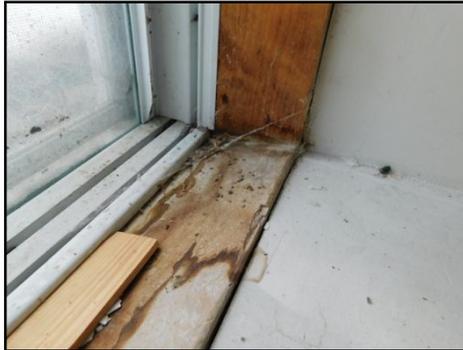
Previous water stain/infiltration. No moisture detected. Monitor the area and repair if needed

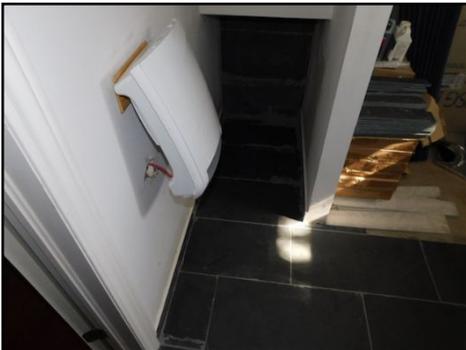
The bathroom is still under renovation/not finished. Missing plumbing, electrical, shower, etc...

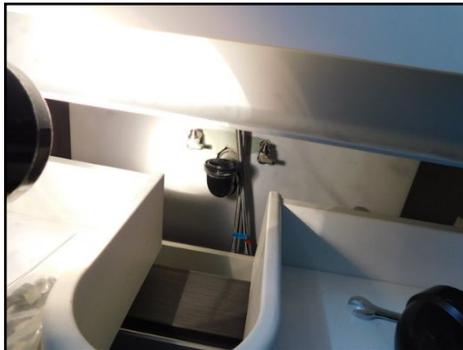
The bathroom is still under renovation/not finished. Missing plumbing, electrical, shower, etc...

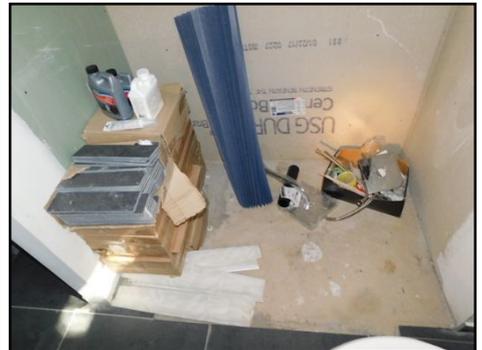
The bathroom is still under renovation/not finished. Missing plumbing, electrical, shower, etc...

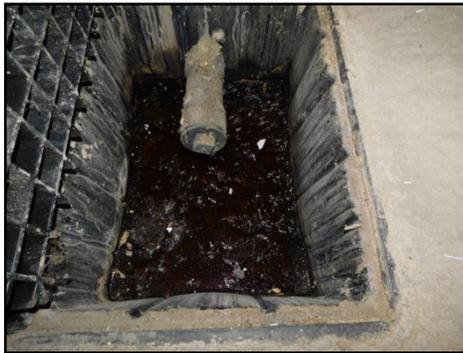
The silt pit needs cleaning and caulking around the drain, this condition could cause water to enter below the slab.

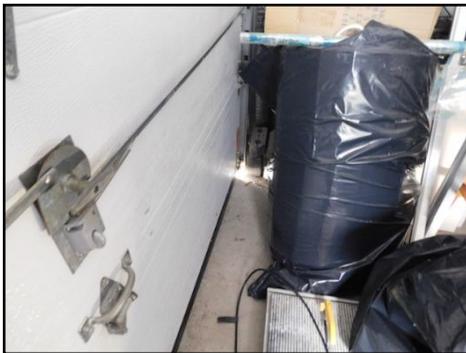
(Visible light) Partial day light was noted on the corner of the garage door. This condition can lead to heat loss and cold temperature during winter. Proper corrections by a qualified contractor is recommended.

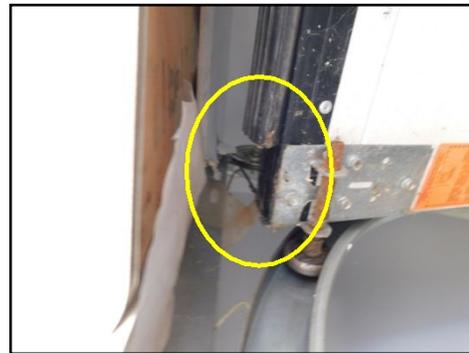
Bottom weatherstrip is short (missing on one end), recommend changing weatherstripping to prevent visible daylight.

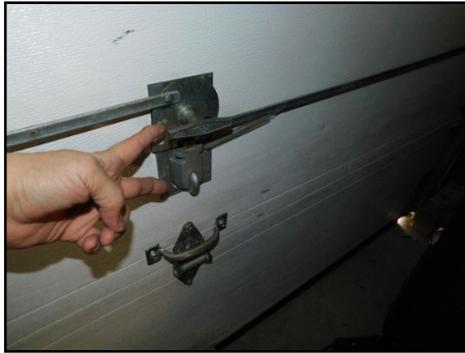
Minor correction needed with the knob, to spring open

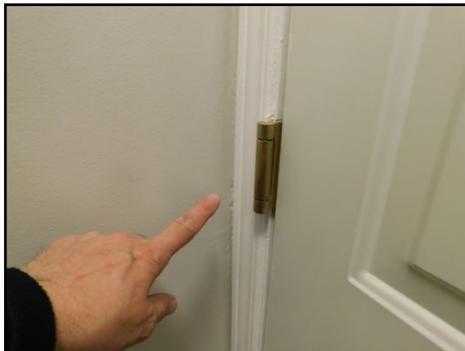
Self closer requires adjustment for proper closing. (This is to prevent carbon monoxide or smoke entering the building). Corrections recommended.

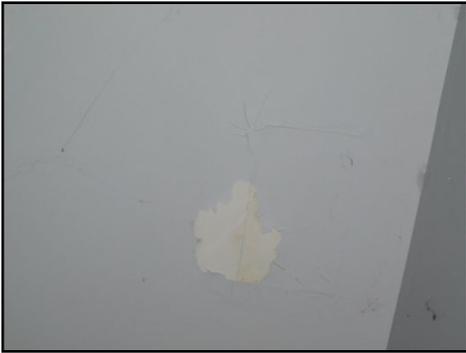
Evidence of past water penetration observed, however it is dry at the time of the inspection.

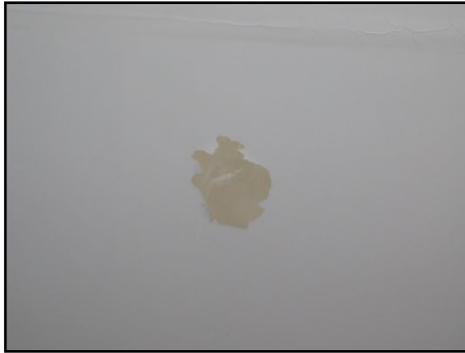
Evidence of past water penetration observed, however it is dry at the time of the inspection.

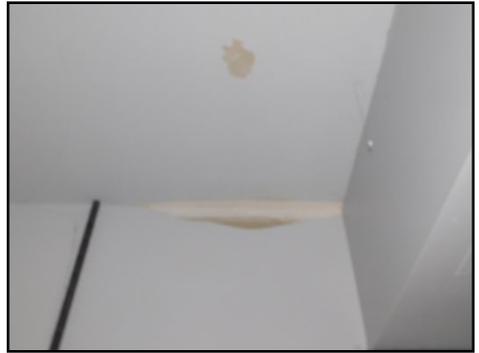
Evidence of past water penetration observed, however it is dry at the time of the inspection.

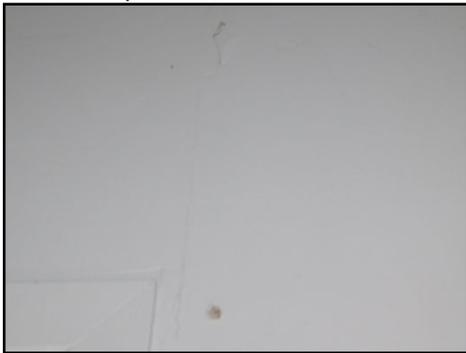
Minor tension crack, repair as needed

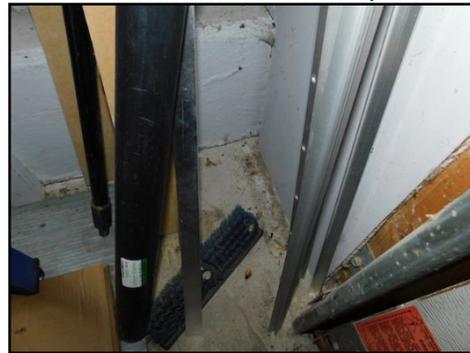
Evidence of past water penetration observed, however it is dry at the time of the inspection.

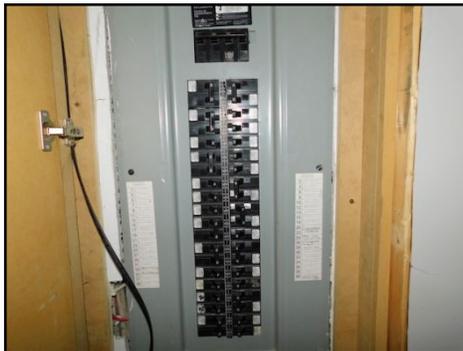
Panel is full. No room for expansion. Upgrading to a bigger panel may/will be needed when updating the electrical in the basement (no light switches) and possibly the basement bathroom.

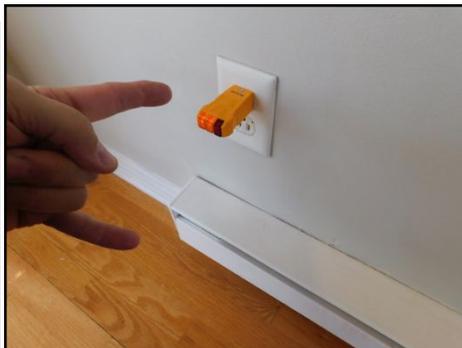
General note: Outlets located above the baseboard electric heaters can burn the wire connections to those outlets creating fire hazard and/or safety hazard.

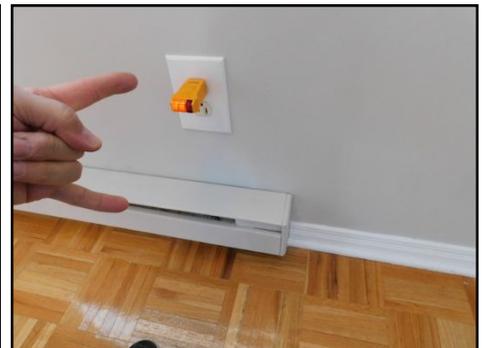
General note: Outlets located above the baseboard electric heaters can burn the wire connections to those outlets creating fire hazard and/or safety hazard.

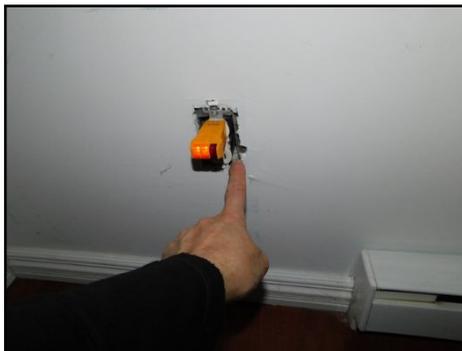
Missing faceplate, this is a safety hazard. Installation needed to enhance safety

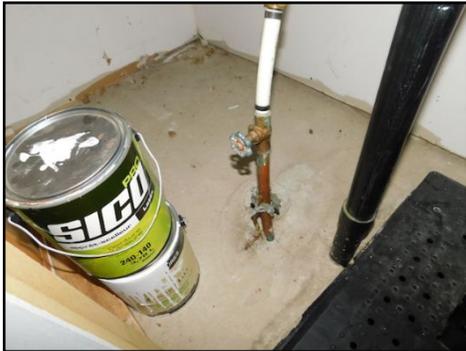
Located just in front of the basement front wall.

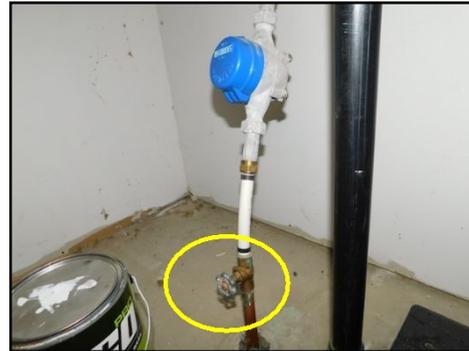
Usable at the time of the inspection, however these types of valve can leak over time. Recommend replacing with a lever type valve.

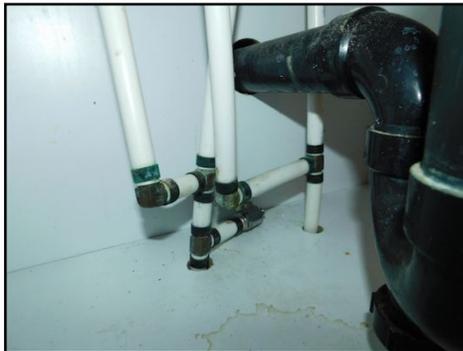
Corrosion observed at some of the fittings, no leaks visible at time of inspection. Recommend review by a licensed plumber for repair or replacement, as necessary, prior to close.

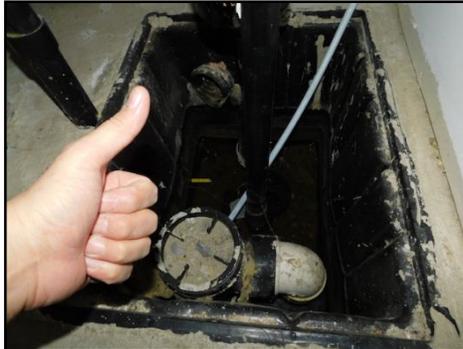
The pump was activated for regular functionality and it is in working condition. Regular check up is recommended to assure functionality. Cleaning recommended.

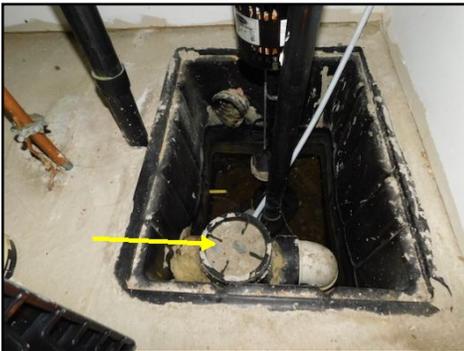
Backwater valve located in the basement, (visible during inspection).

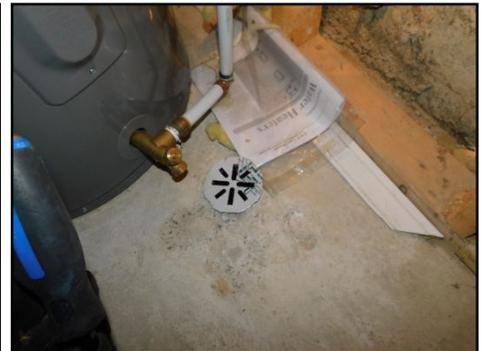
The floor drain is located in the basement, next to the hot water tank, however the efficiency of the floor drain is not within the scope of this inspection. (Floor drain may dry out over time and letting sewer smell entering the building. Adding water on regular basis is recommended)
