# PROPERTY INSPECTION REPORT

**Inspection Address:** 1234 rue Example, Laval

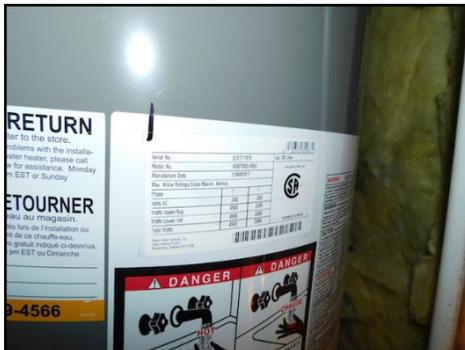
Year manufactured: 2017

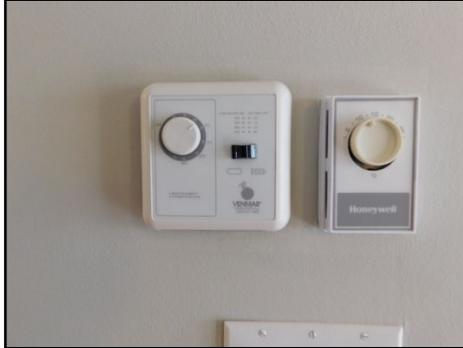
A panel/switch was on the wall, however, nor air exchanger unit was found. It appears it just draws in air through the exterior vent when turning on the switch.
